Archbishop House

Baltimore, MD**CONTRACTOR – Worcester Eisenbrandt Inc., Baltimore, MD**
ARCHITECT – Cho Benn Holback and Associates, Baltimore, MD**Protective Coatings****Summer/Fall 2015****PROJECT TASK**

Replace deteriorating materials, waterproof and restore appearance of the exterior wall system.

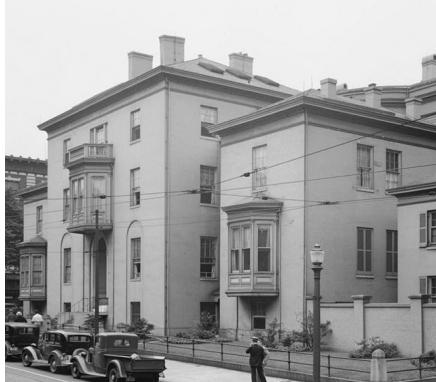
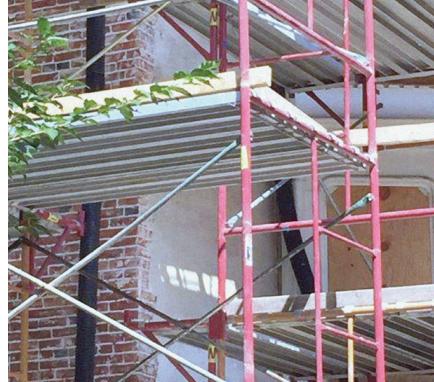
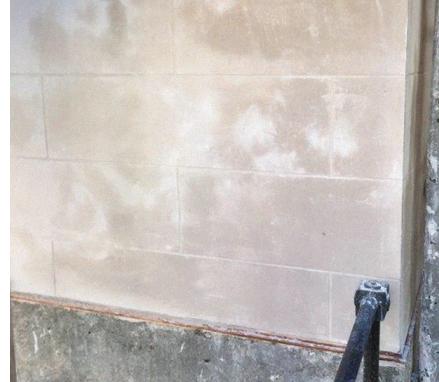
Top three photographs were taken "before and during" and the bottom three photographs were taken "after" the work was completed.

Restoration efforts included removal of the Formstone and resurfacing the deteriorated underlying porous brickwork with scored stucco. The walls were primed to provide a stable substrate and coated with a mineral silicate paint to provide protection from environmental pollution and acid rain. The finish color was chosen to match the original color of the historic 1865 structure. Conproco worked with Worcester Eisenbrandt's historical preservationists to

insure a desirable color match using Primex, a clear primer, and M3P, a paint-like material used to replicate the original color and protect the stucco substrate against water infiltration and carbonation. M3P does not form a film on the surface like paint, and will not blister, flake or peel minimizing need for future maintenance. Applicators rolled on the top coat giving the scored stucco a finished mortar joint appearance. Repairs were made to the brownstone capped brick privacy wall to fill in chipped edges and nail holes with color-matched Mimic.
