BASD Stadium Grandstands

Bethlehem, PA**ENGINEER – D’Huy Engineering, Inc., Bethlehem, PA**
CONTRACTOR – Culbertson Restoration, Ltd., West Chester, PA
DISTRIBUTOR – TB Philly, Phoenixville, PA**Concrete Repair & Protective Coatings**
Summer 2012**PROJECT TASK**

Repair freeze/thaw damage to the concrete elements of steel grandstands.

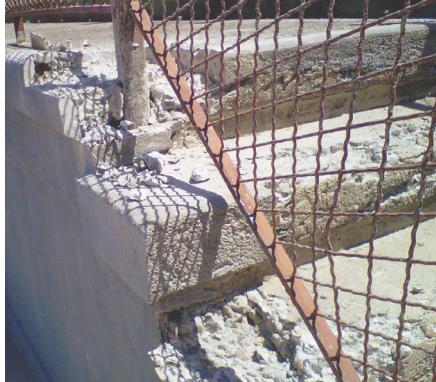
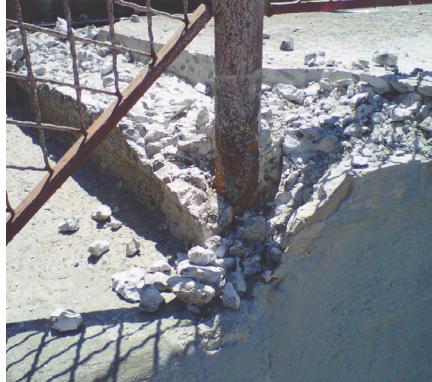
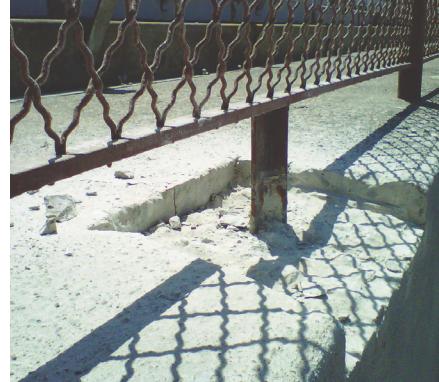
Top three photographs were taken "before and during" and the bottom three were taken "after" the work was completed.

Each steel grandstand is anchored in place by 2 long concrete structures which include the steps and lowermost walkways. The steel grandstands expand and contract a great deal, even in the course of a single day. Years of freeze/thaw cycling had taken a toll on the concrete elements, which serve as concrete "curbs" and keep the structures from moving forward.

Concrete repairs were completed using Conpro Primer as a bonding primer for repair materials to hardened concrete,

Conpro One Shot 2C, a resurfacing material, and Conpro Set repair mortar. A breathable waterproof pedestrian deck coating system, consisting of Elastideck and Super Color Stain, was then applied. Conpro Lastic elastomeric paint was applied as a protective waterproof coating to the vertical surfaces.
