PROSPEC® PENETRATING SEALERS COMPARITIVE PERFORMANCE EXAMPLES

The images below illustrate the depth of penetration of various ProSpec® Sealers. These 2" mortar cubes were immersed in the corresponding sealer for 1 minute, allowed to dry, and split in half. A contrast treatment was then applied to the split face surface allowing for a visual representation of surface penetration. (The limestone portion of the mortar cube reveals the depth of penetration. The black portion reveals area where the sealer did not reach.)

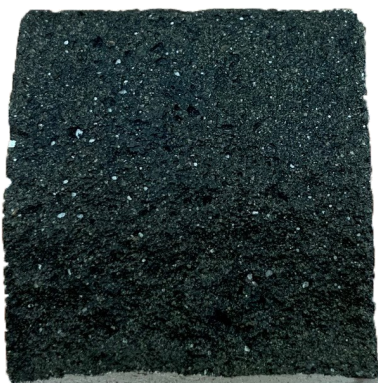
Control

No exposure
No penetration
0% active content
0 years weather protection

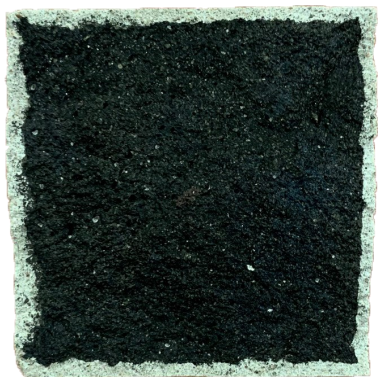
ProSpec® Concrete & Masonry Sealer WB

8% active content
60 second exposure
1–2mm (1/16") active penetration
~4–8 years normal weather protection*

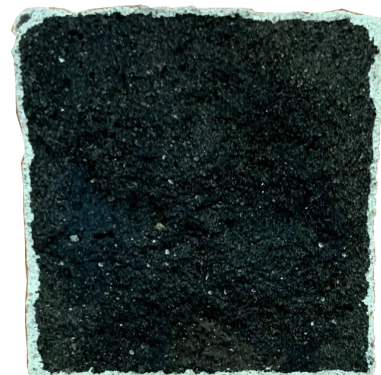
ProSpec® Siloxane Sealer

10% active content
60 second exposure
2–3mm (1/8") active penetration
~8–12 years normal weather protection*

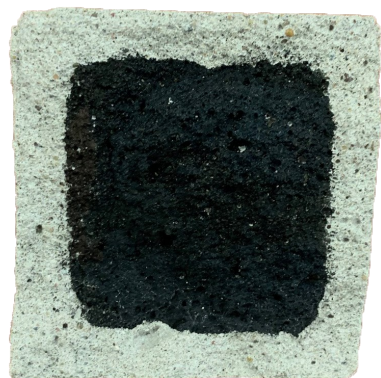
ProSpec® 100% Silane Sealer

100% active content
60 second exposure
7–8mm (+1/4") penetration
~28–32 years normal weather protection*

* 3mm penetration equals 12 years protection / study by Khanzadeh, Subrink, & Ley 2016 with Oklahoma DOT
