# Lloyd House

**Menominee, MI**

**Concrete Repair  
Summer-Winter 2013**

Repair and restore the Lloyd House's deteriorated concrete façade.

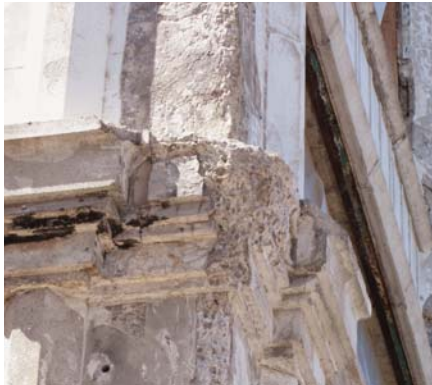
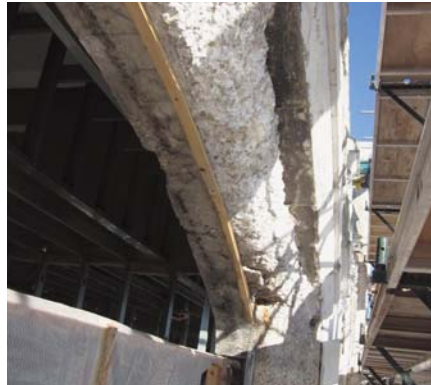
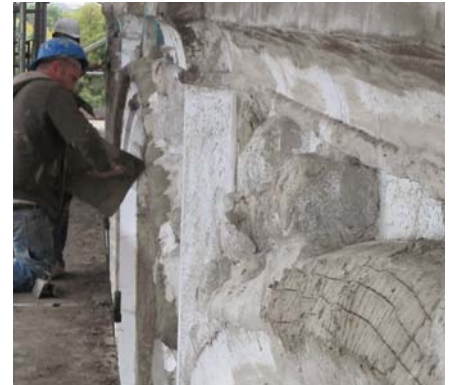
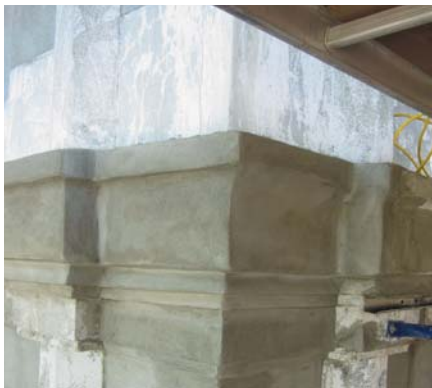
Top three photographs and bottom left were taken "before and during" and the bottom center and right were taken "after" the work was completed.

The four-story concrete façade was crumbling. Chunks had been falling off for years. Erickson Plastering removed damaged areas, and then proceeded to coat exposed rebar with ECB corrosion inhibitor to prevent future spalling. Conpro Set repair mortar was then used to reconstruct the façade. Plastermix, a Portland cement finish coating, was then used to obscure the repair areas and provide the building with a uniform and beautiful finish. In 2015, the WODA Group received the Governor's Award for Historic Preservation for the project.
