111-115 Montague Street

Brooklyn Heights, New York

**Stone Repair
Summer 2004**

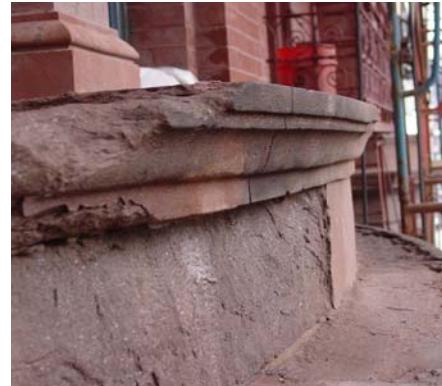
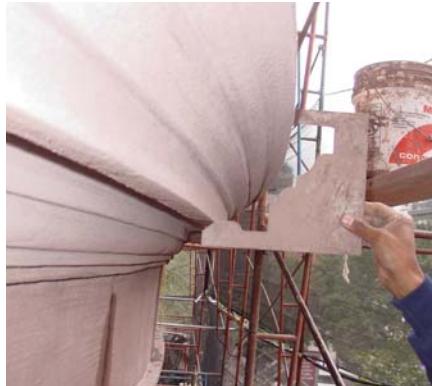
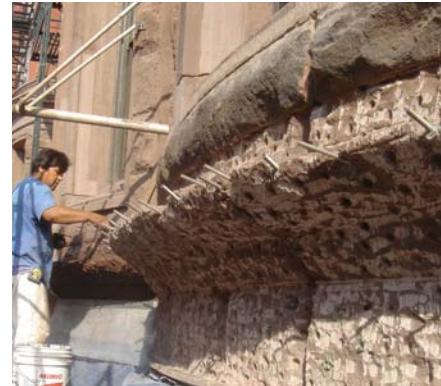
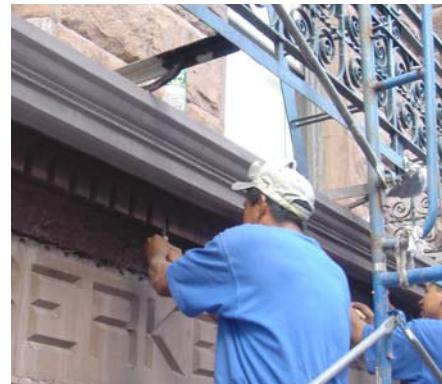
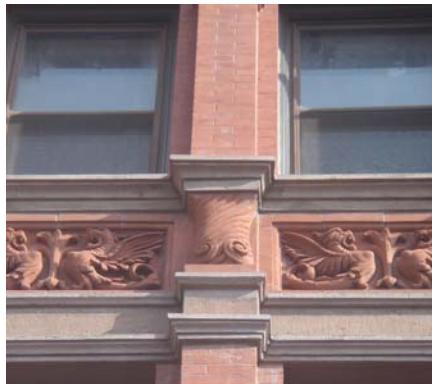
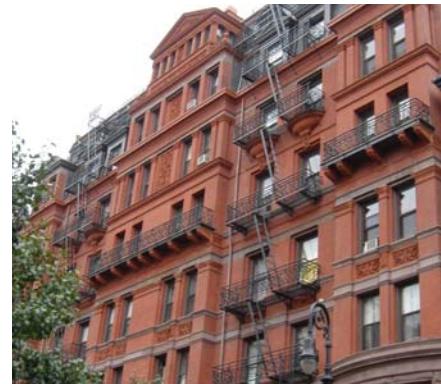
Top three and bottom left photographs are "before" and "during"; the other two were taken after the work was completed.

To ensure the massive MIMIC repairs were well bonded to the substrate, Juno Contracting combined the use of a slurry coat, drilled holes, and epoxy anchored threaded rods.

Over the summer of 2004, Juno's masons carefully removed the deteriorated brownstone and recreated the architectural elements with MIMIC stone repair mortar.
