1818 Market Street

Concrete Repair

Repair and restore façade damage on a high rise office building caused by rebar corrosion.

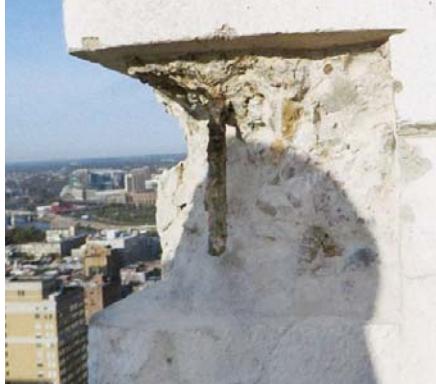
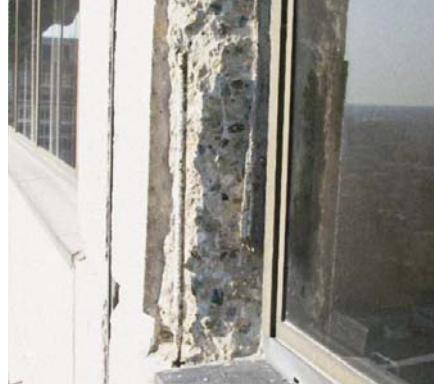
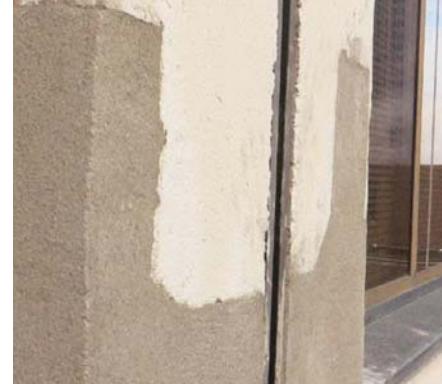
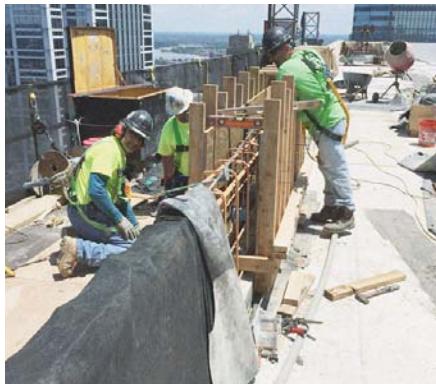
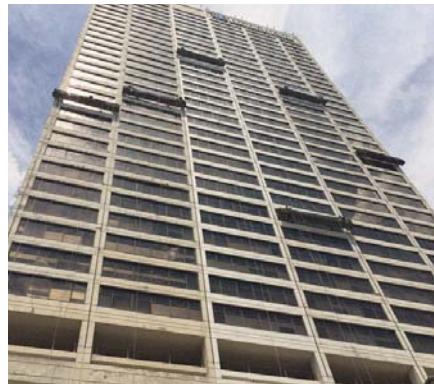
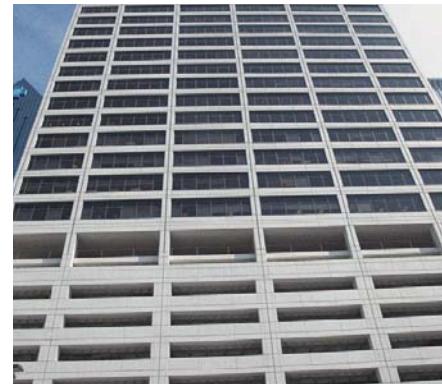
Before and after photographs taken of the 1818 Market Street project. Photographs courtesy of Masonry Preservation Group and Joseph P. Callahan Inc.

Throughout its 40+ year life, 1818 Market Street has undergone multiple renovations due to corroding rebar and spalling. All exposed rebar was treated with Conproco's ECB, a zinc-based primer and passive barrier coating that is not a bond breaker when applied to the concrete substrate. This single component, water-based product has up to a 5 day open time making for easily application and cleanup on high rise jobs like this. Its orange color makes it even easier to inspect full coverage.

To achieve a faster set on all vertical repair areas, the contractor trowel applied Quick Shot, our fastest setting cementitious repair mortar. ISR Deck Mix was used on all horizontal applications, including long form-and-pour repairs at the parapets.
