# 551 Congress Street

## Portland, Maine

**Concrete Repair**  
**Stone Repair**  
**Protective Coatings**  
**Summer 2006**

Repair and protect a building damaged by repeated freeze-thaw cycles.

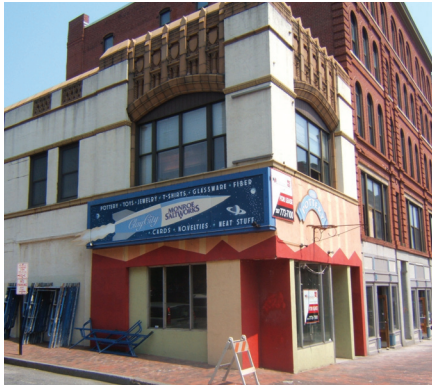
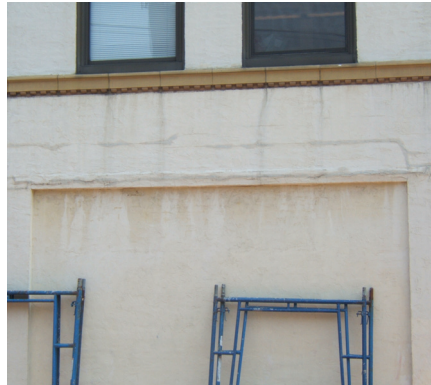
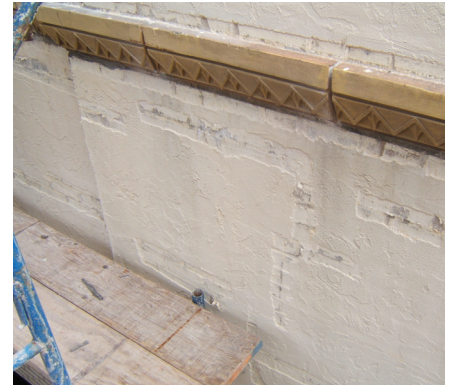
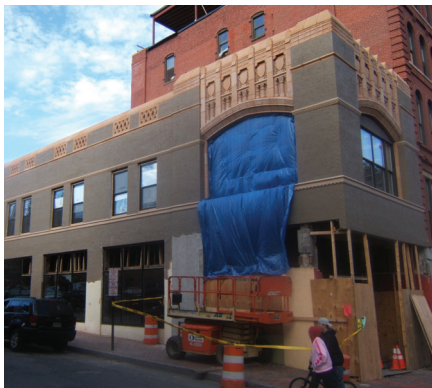
Top three and bottom left photographs were taken "before and during" and the bottom center and right were taken "after" the work was completed.

The building is constructed of concrete block with sandstone detailing. The building was covered in cracking stucco, which was caused by water infiltration and repeated freeze/thaw cycles.

The stucco was removed, and a layer of Structural Skin was applied. Structural Skin is a fiber-reinforced structural cement coating, which provides waterproofing and a smooth surface. The concrete block was then finished with Conpro Lastic, in a shade much darker than the previous finish. Conpro Lastic is a pigmented, waterproof coating. The sandstone repair work was accomplished with MIMIC, a color-matched repair mortar for natural stone. The sandstone was then coated with Conpro Shield W water repellent.
