# Baltimore Hyatt Regency

**Protective Coatings**

## PROJECT TASK

Restore appearance and waterproof broken rib precast concrete wall.

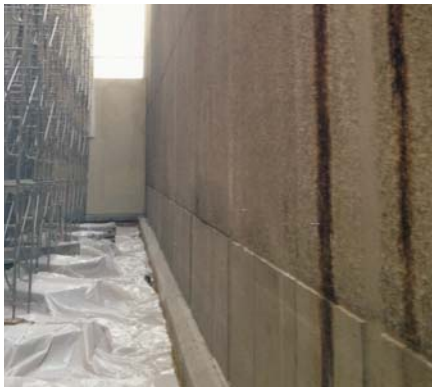
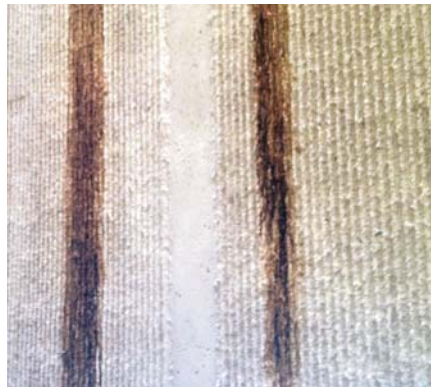
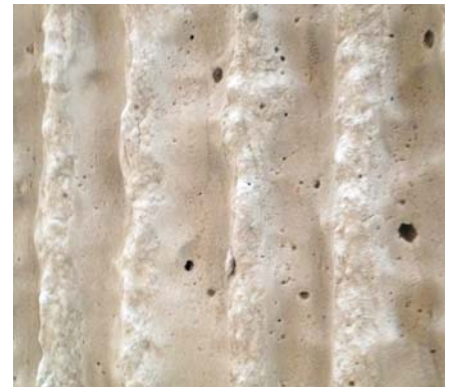
Top three photographs were taken "before and during" and the bottom three photographs were taken "after" the work was completed.

The concrete wall within the hotel's bistro contained unsightly floor to ceiling rust colored water marks. The stains on the façade were removed during the cleaning process and the wall was pre-treated with Primex and then coated with M3P Stain to enhance

the uniformity of the color. M3P Stain is natural in appearance but comes in 34 standard colors and will not peel, blister or flake. It resists fading and serves as a water repellent, mitigating carbonation and providing long term protection and enhanced aesthetics of concrete, masonry and stone.
