Basilica of the Assumption

Baltimore, MD

**Stone Repair
Spring 2013**

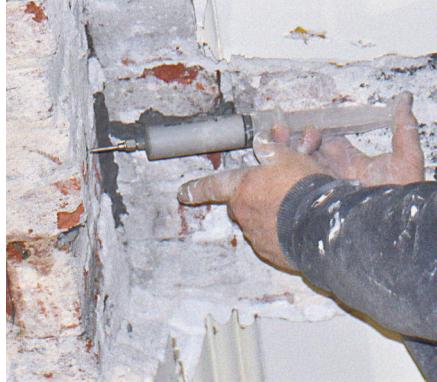
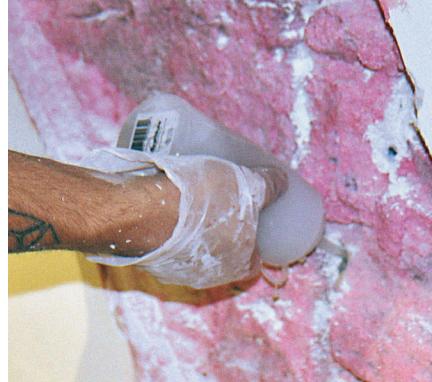
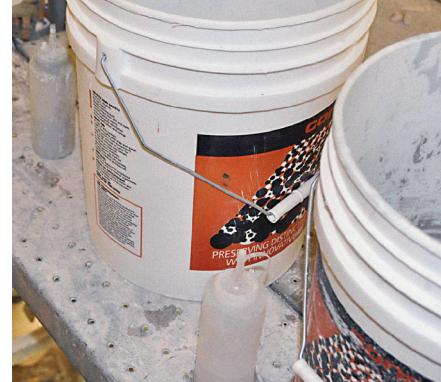
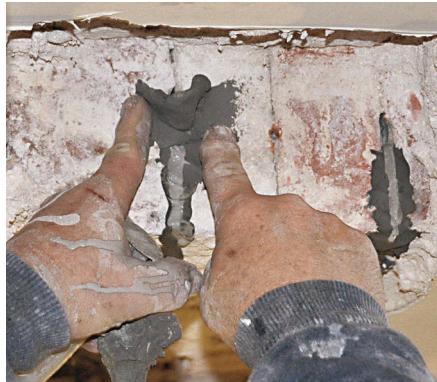
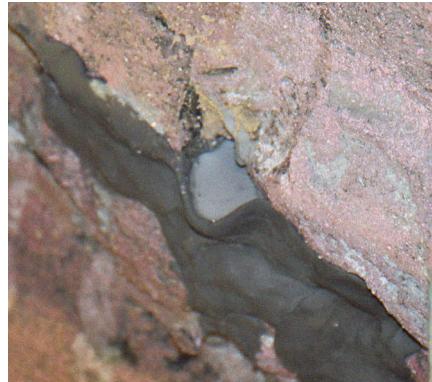
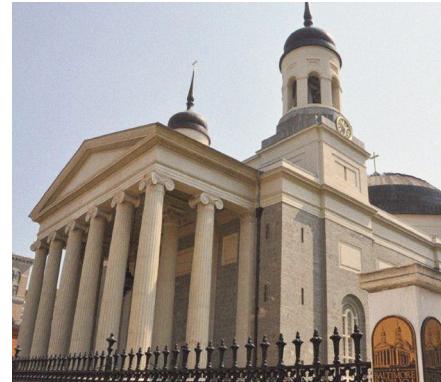
Top three photographs and bottom left and center were taken "before and during" and the bottom right was taken "after" the work was completed.

In the summer of 2011 an earthquake caused considerable damage to a number of buildings in the area including the Washington Monument, the Smithsonian Castle and the Basilica of the Assumption. At the Basilica, the movement caused cracking in the plaster finish of the ceiling domes that covered the brick backup. Approximately 600 lineal feet of cracks ranging from hairline to 2 inches wide and from several inches to up to 24 inches deep were identified as needing repair. Smaller cracks were addressed by drilling

ports and filling with Conproco Injection Grout, a cementitious micro-grout that is unique in that can fill cracks from hairline to 2 inches wide. For larger cracks the plaster was removed and Injection Grout was pumped into the voids in the brick backup caused by the earthquake. Some arches were reinforced with customized anchor systems to stabilize the backup the masonry in conjunction with the newly installed grout. The plasterwork was restored and recoated to complete the renewed finish.
